There are many reasons for rotary joint leakage. This chapter only deals with leakage caused by uncleaned internal fluids. In this case, the rotary joint can be inspected and the cause determined by examining the seal rings.

旋轉接頭洩漏的原因很多，本篇僅針對內部流體不潔而造成異常洩漏現象做說明；此情況可檢視接頭內部的重要零件－封環，視其運轉磨耗情形做簡易的研判。

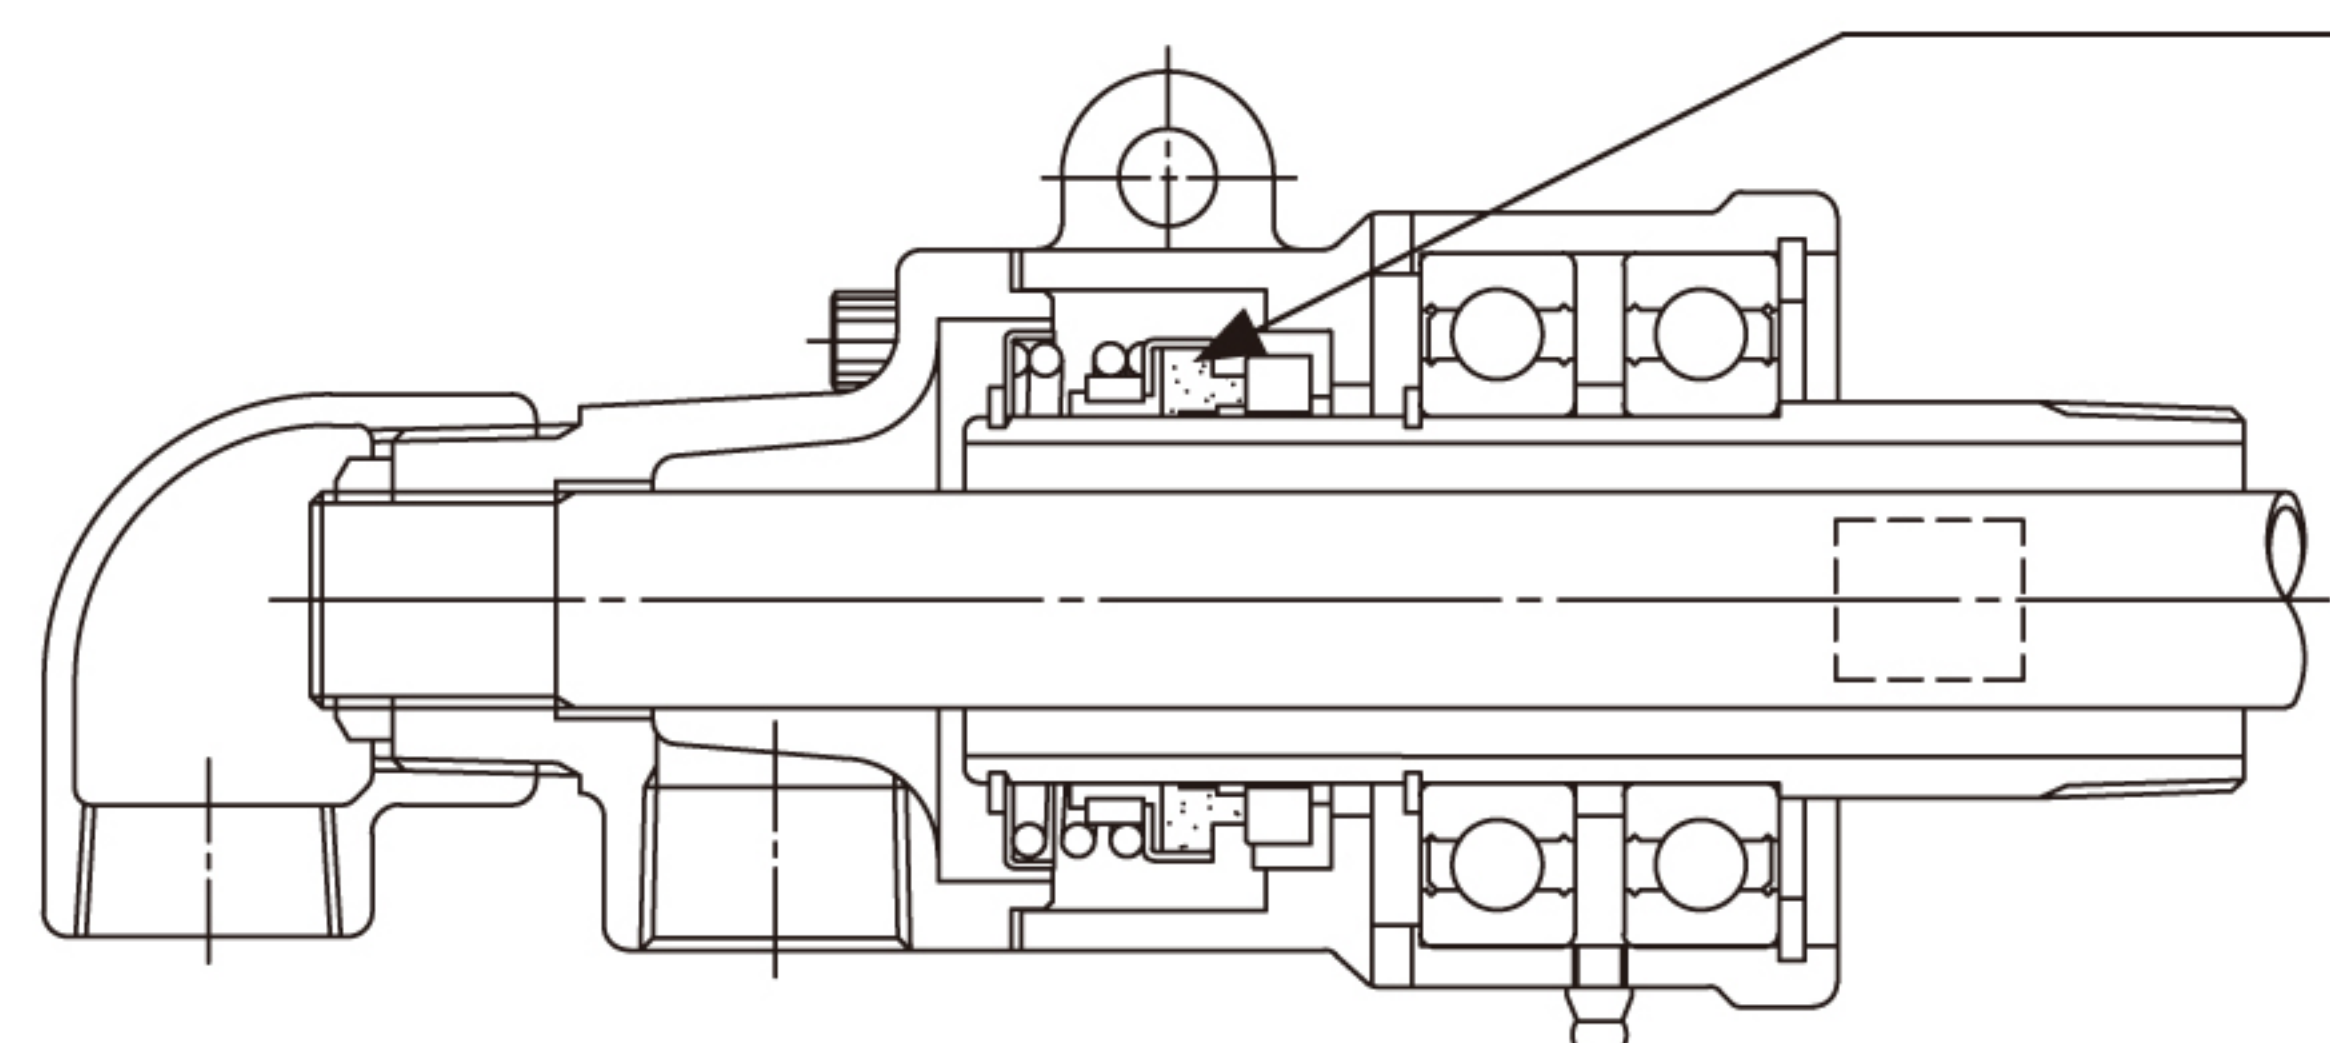
Fig.2

If there are no impurities in the seal face, it will be smooth and bright. Any leakage would therefore most likely not have been caused by unclean fluids.

封環摺動面無雜質入侵，平滑又光亮。如因旋轉接頭洩漏經檢視為此現象時，應不是流體不潔所造成的。

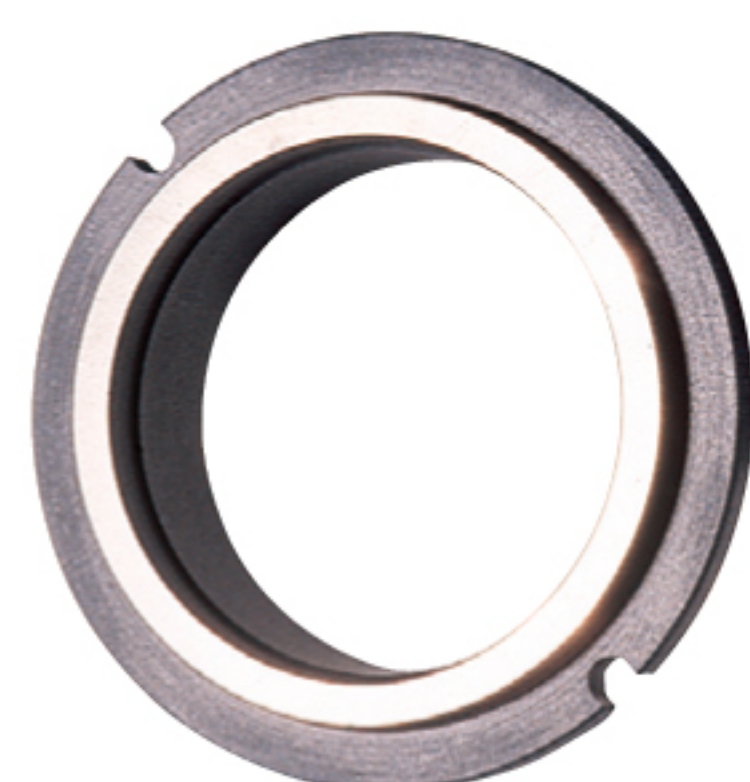
Fig.3

If impurities get in the seal face, they will cause it to become rough and dull. In this case, unclean fluids would be mainly responsible for any leakage.

封環摺動面雜質入侵造成粗糙，不平滑無亮度，不能止漏。如因旋轉接頭洩漏經檢視為此現象時，即為流體不潔造成的主要原因。

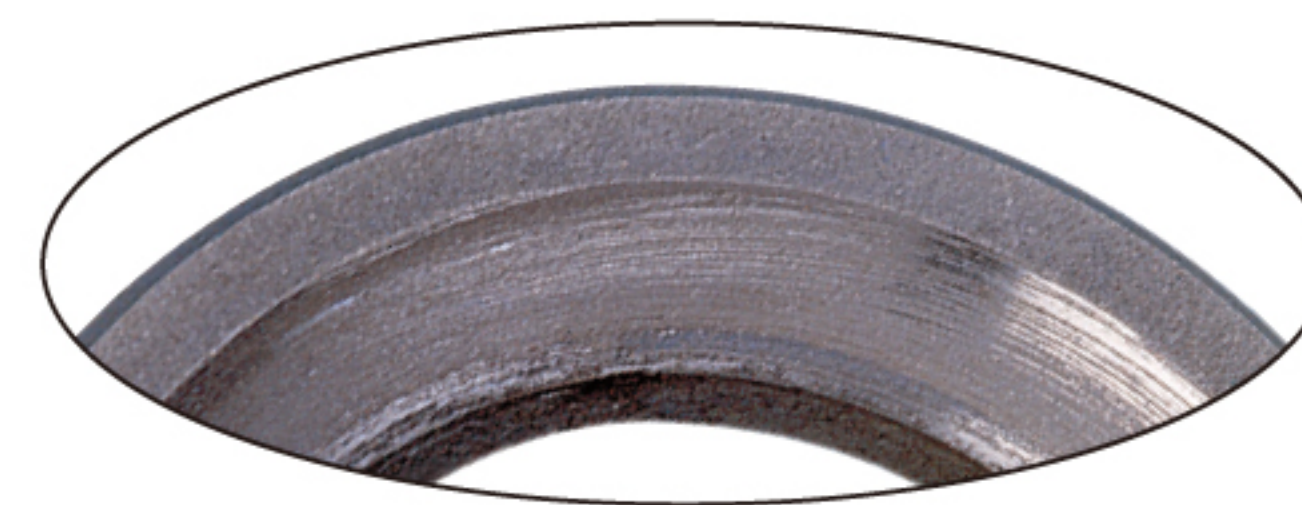
Fig.7

The severe wear shown was caused by coarse impurities. This will result in a lot of fluid being lost.

所示為很粗的不潔物造成嚴重的磨損，此狀況流體會大量洩漏。

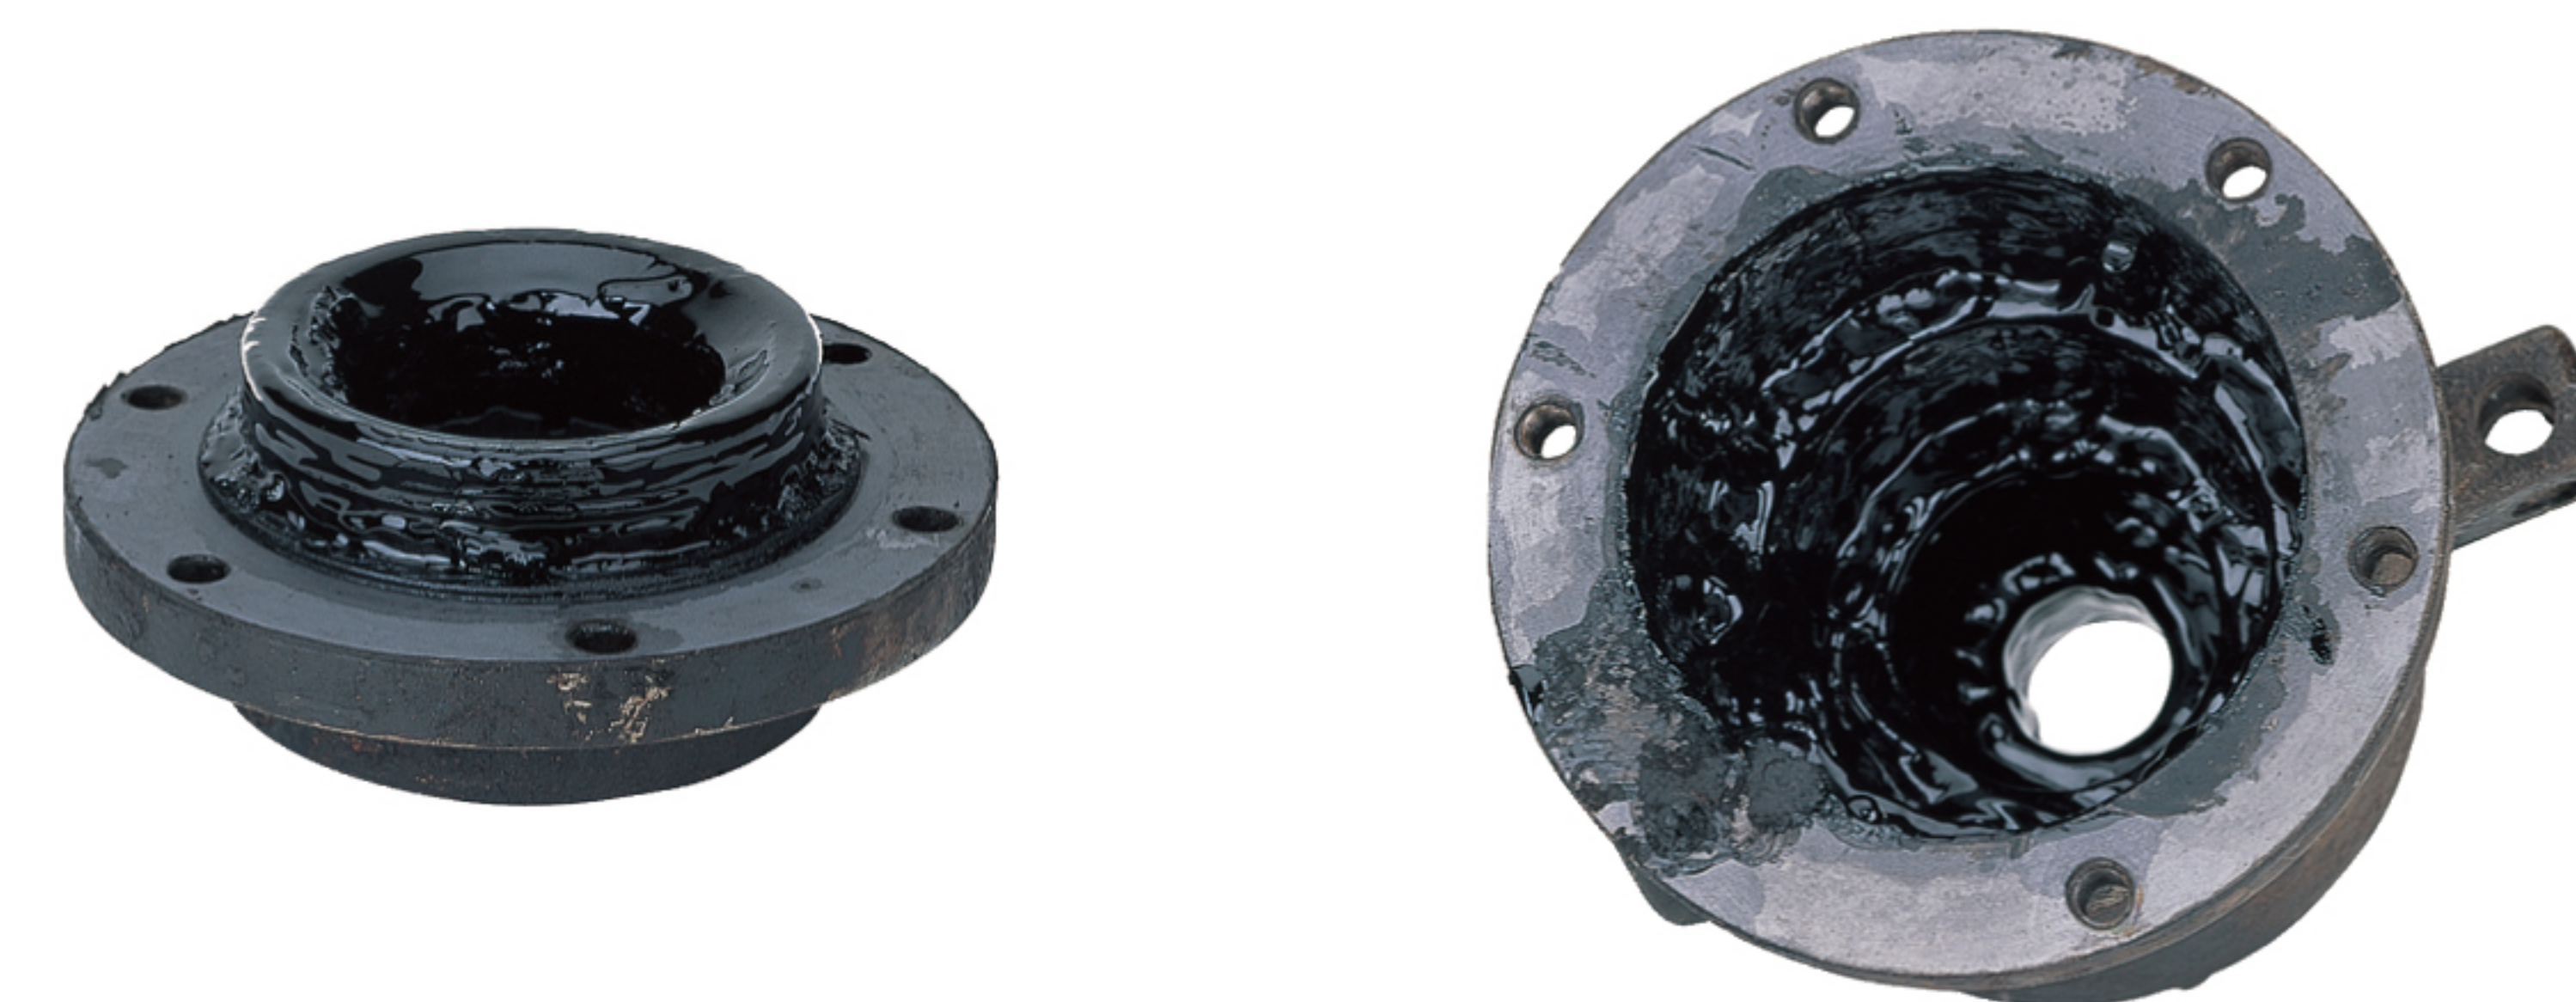
Fig.8

This rotary joint is used with mixing rolls. Leakage after 3 months of normal use was because there were many impurities and the quality of the oil was bad.

此只旋轉接頭使用於軋輪機；開機時運轉正常，使用約3個月後，開始洩漏。經檢視發現內部夾雜有很多雜質，油質亦不良。
