FOLLOW-UP OF SAND-IMPURITIES

雜質、鐵沙清理後續

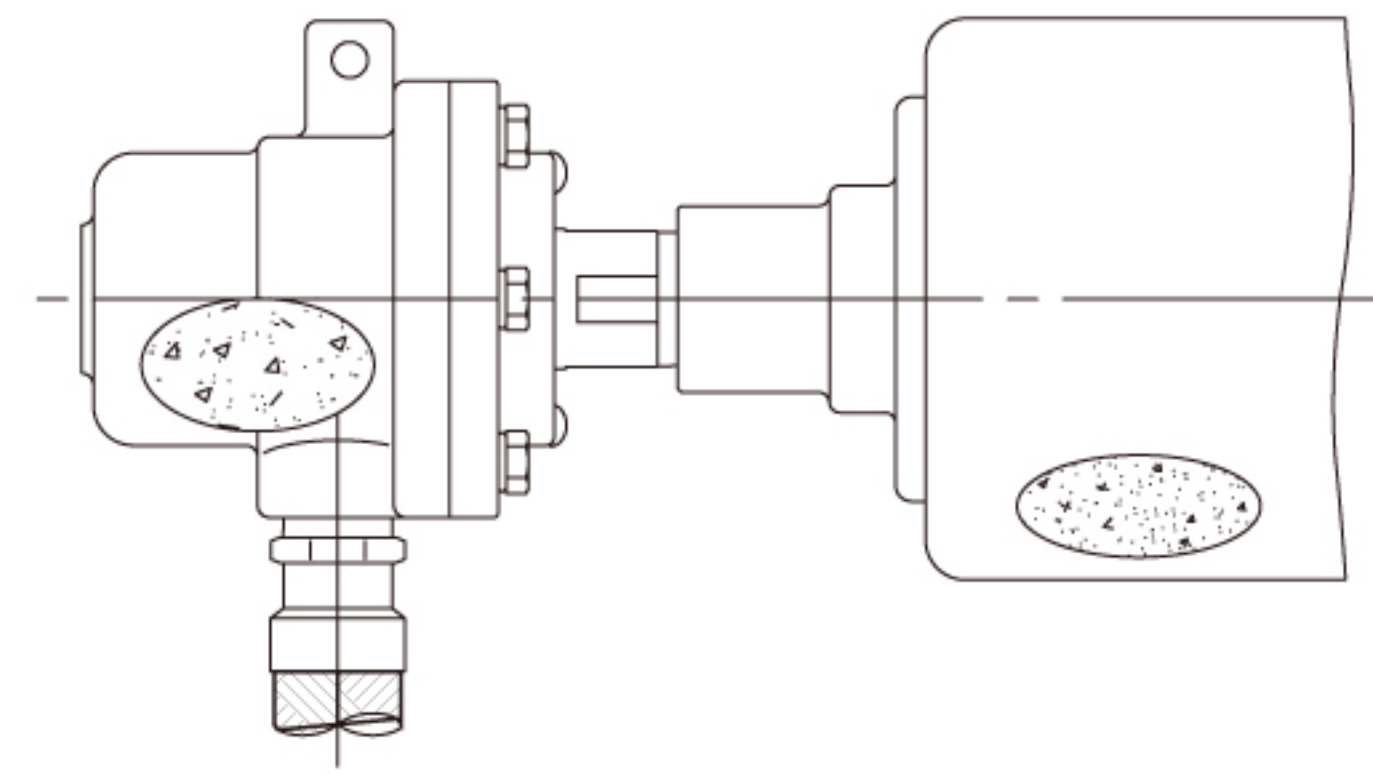
It's so trouble finding pellets and impurities in tube or roller.

管路滾輪內有雜質、鐵沙是一件很麻煩的事。

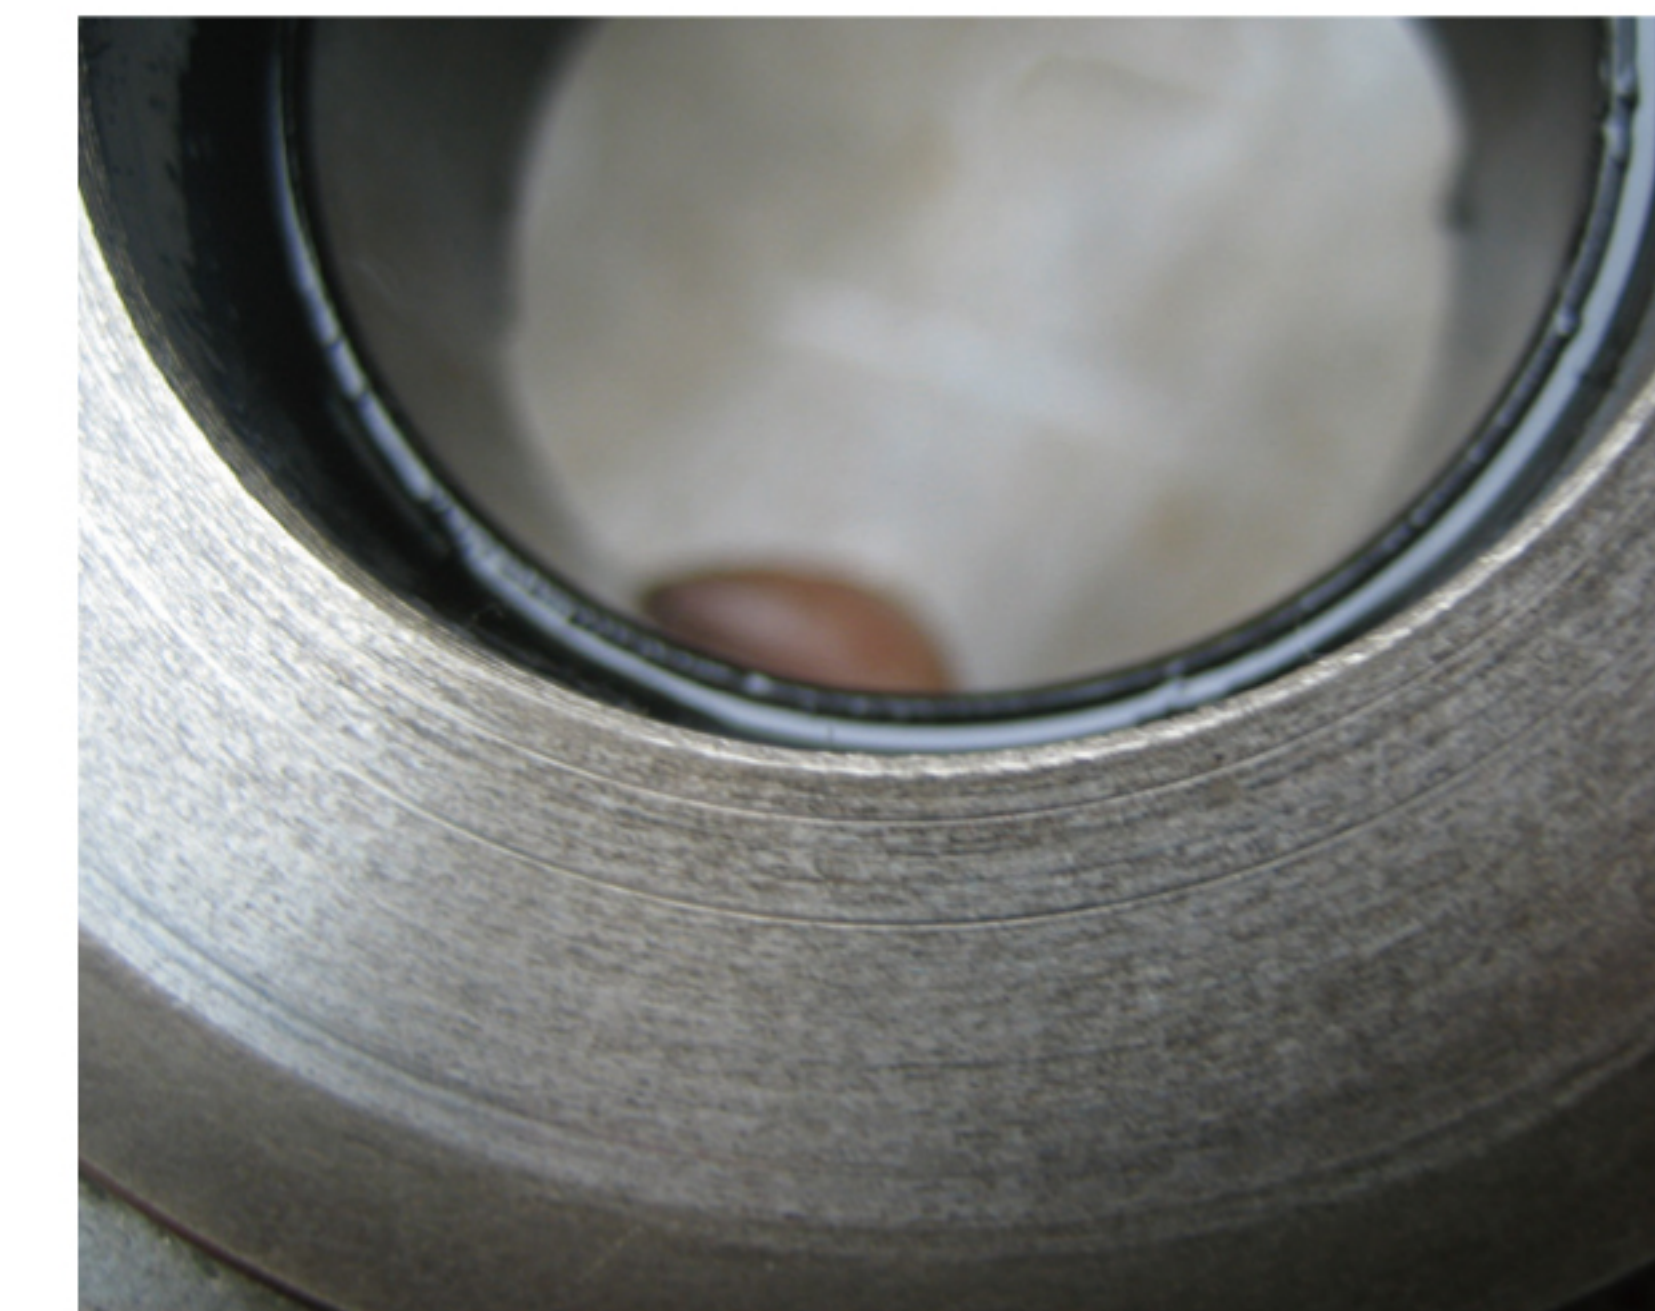
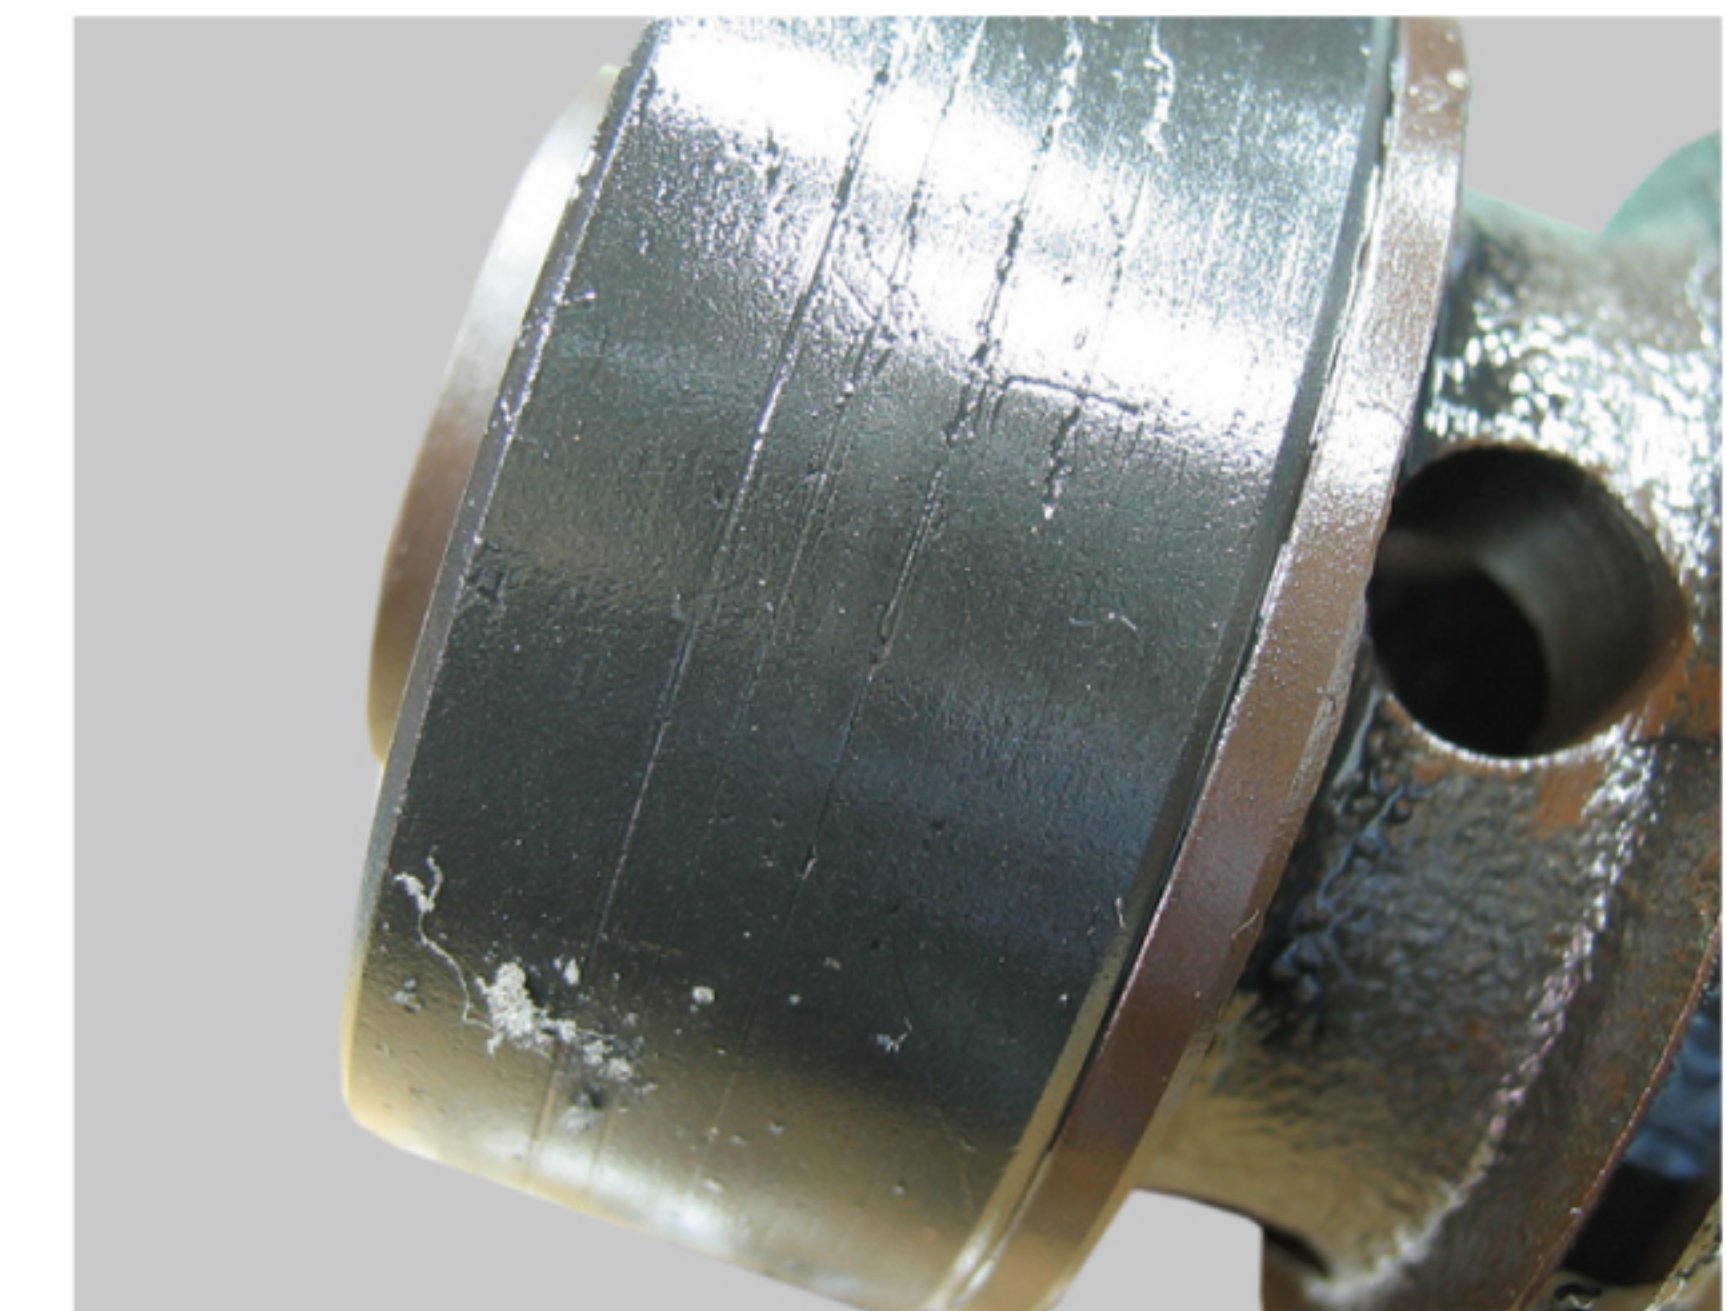
1. Carbon parts have been damaged and the level of leaking just depends on how serious the damage is. For most occasions, by well-fixing it we have to return the joints back to the original manufacturer.
2. What if the leaking problem hasn't been improved after installing the fixed / new joints?
 - a. There're still pellets and impurities in the tube or rollers, all process are required to be done again.
 - b. It's not acceptable being neglected about the other 2 factors, fixed structure and the installment of flexible hoses.

LIGHT DAMAGE

輕度磨損

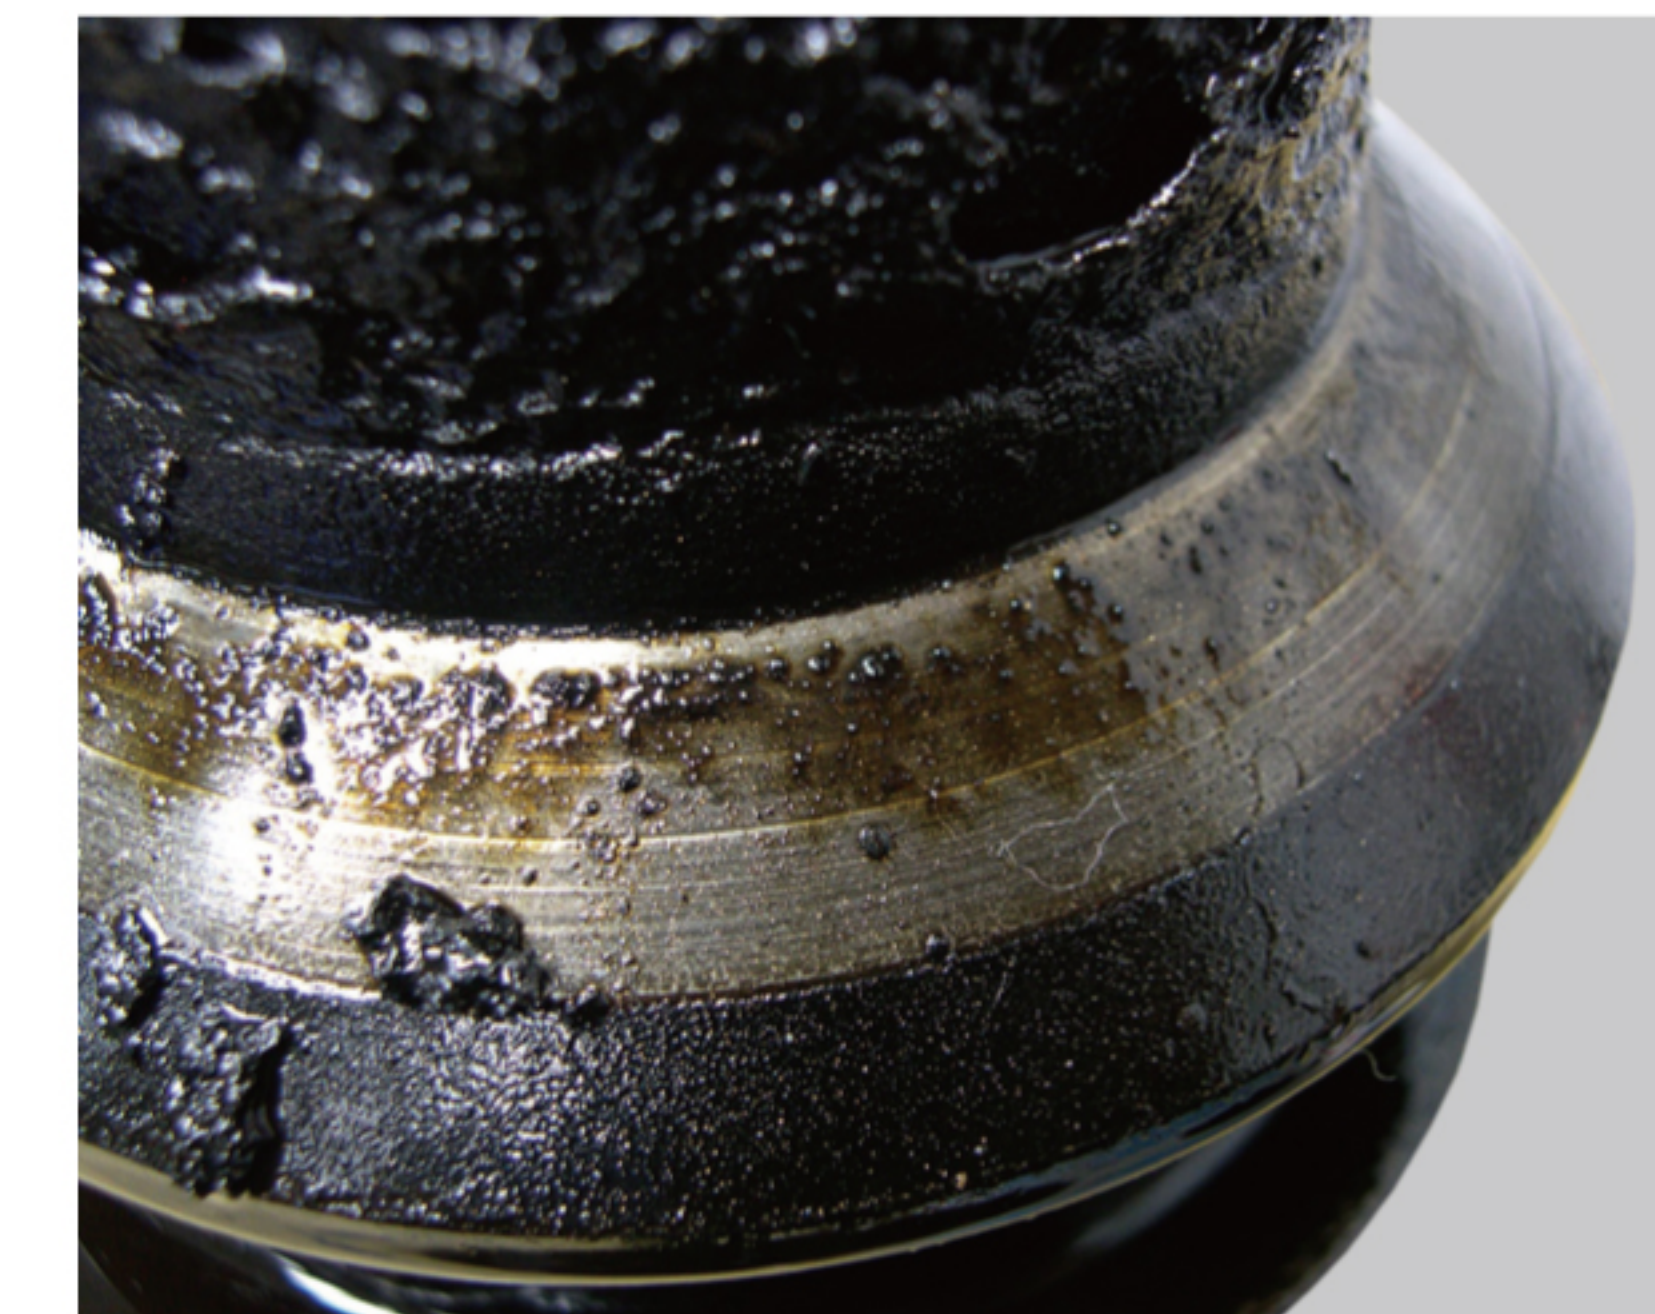
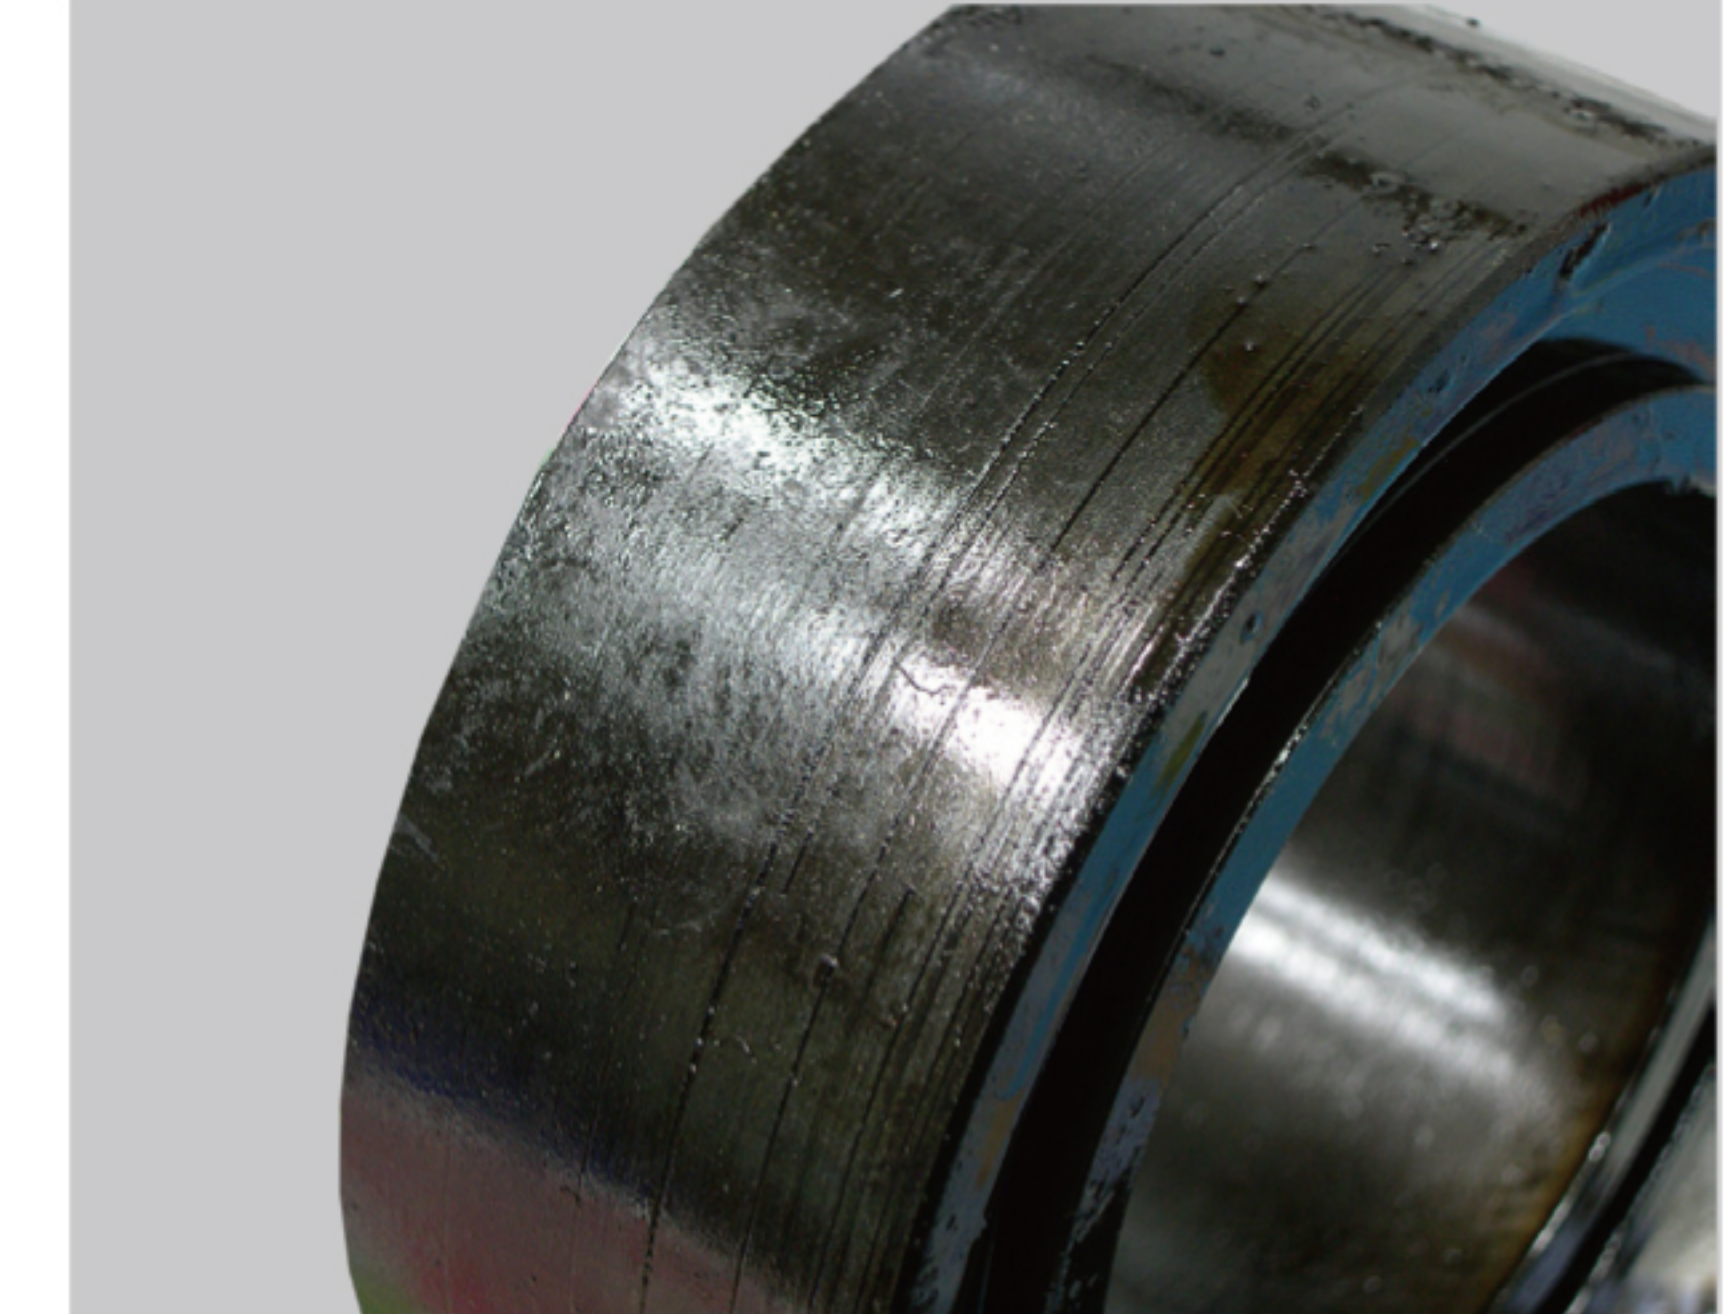
MODERATE DAMAGE

中度磨損

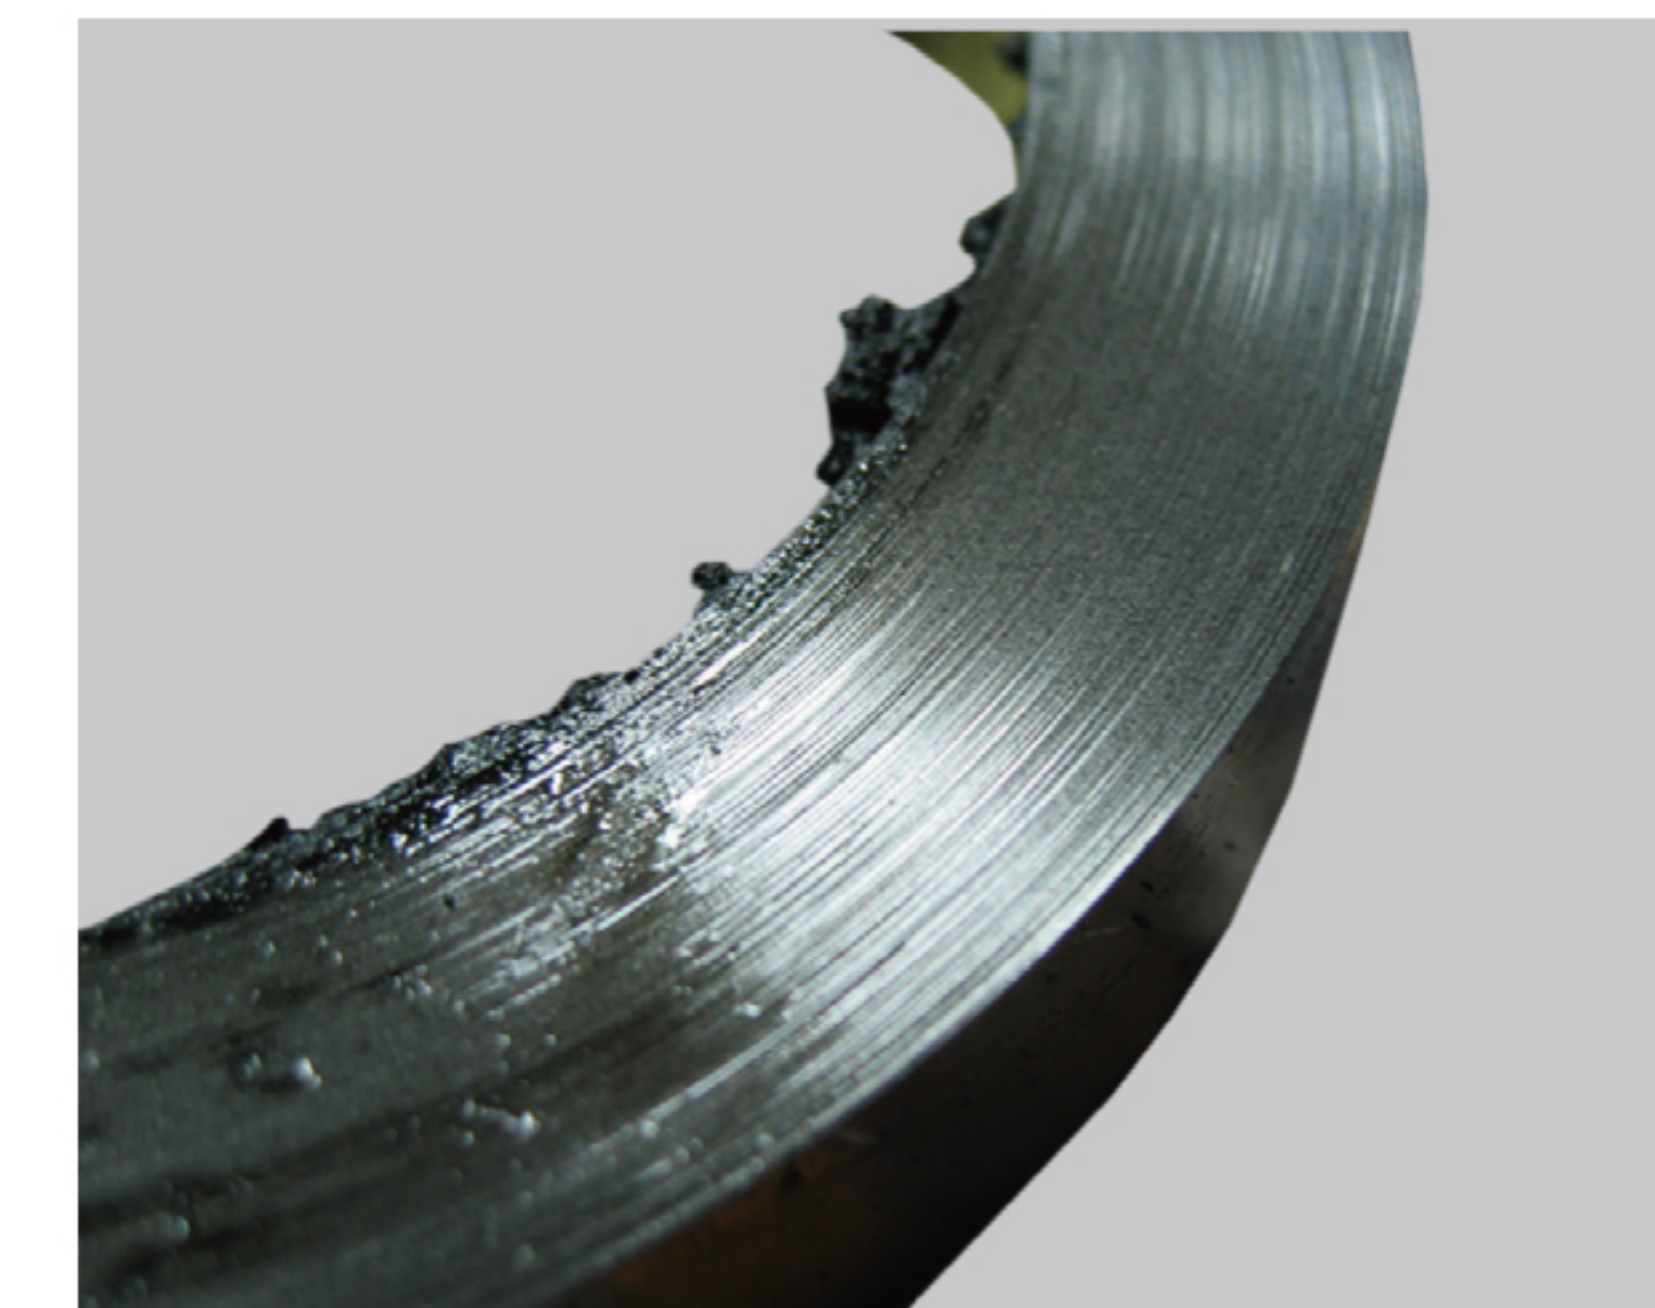
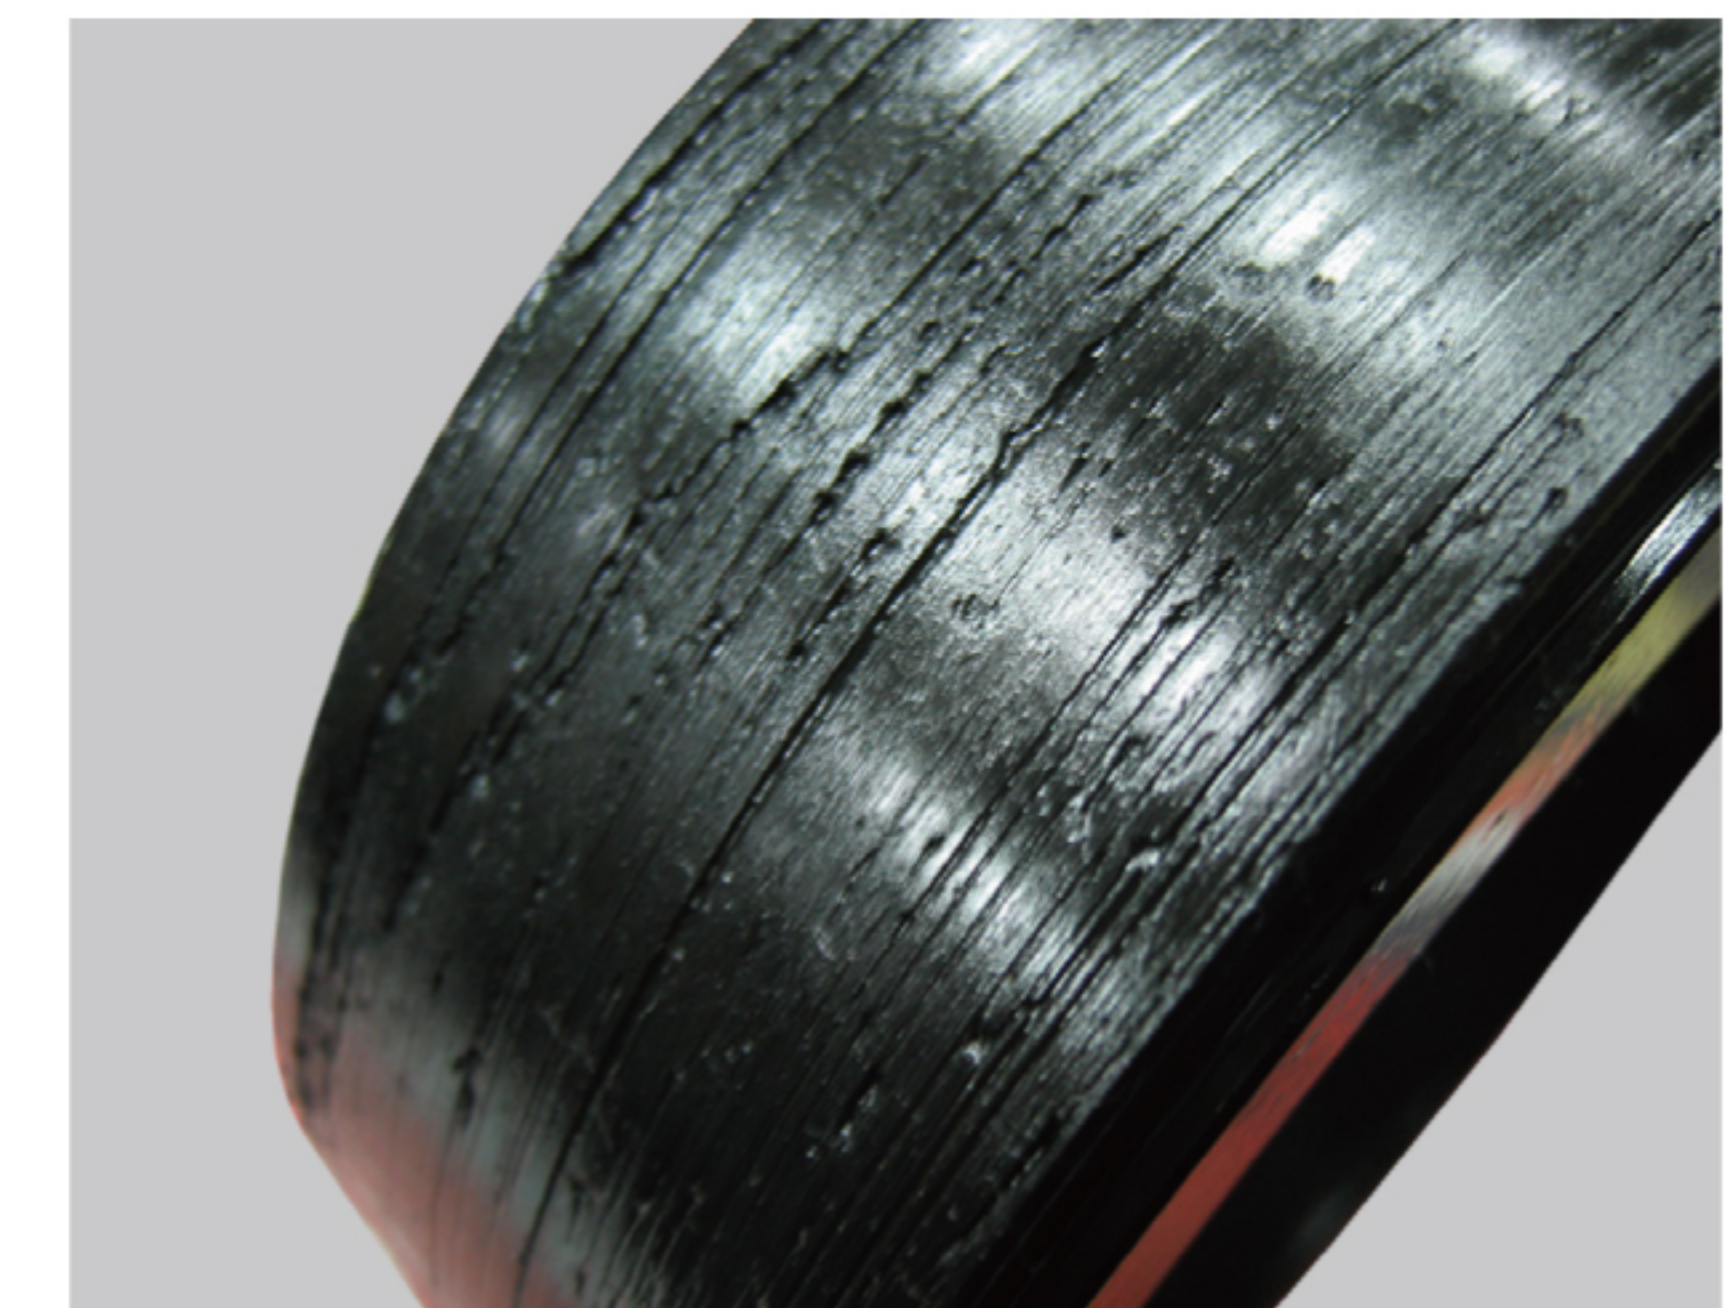
SEVERE DAMAGE

嚴重磨損
