FOLLOW-UP OF SAND-IMPURITIES

雜質、鐵沙清理後續

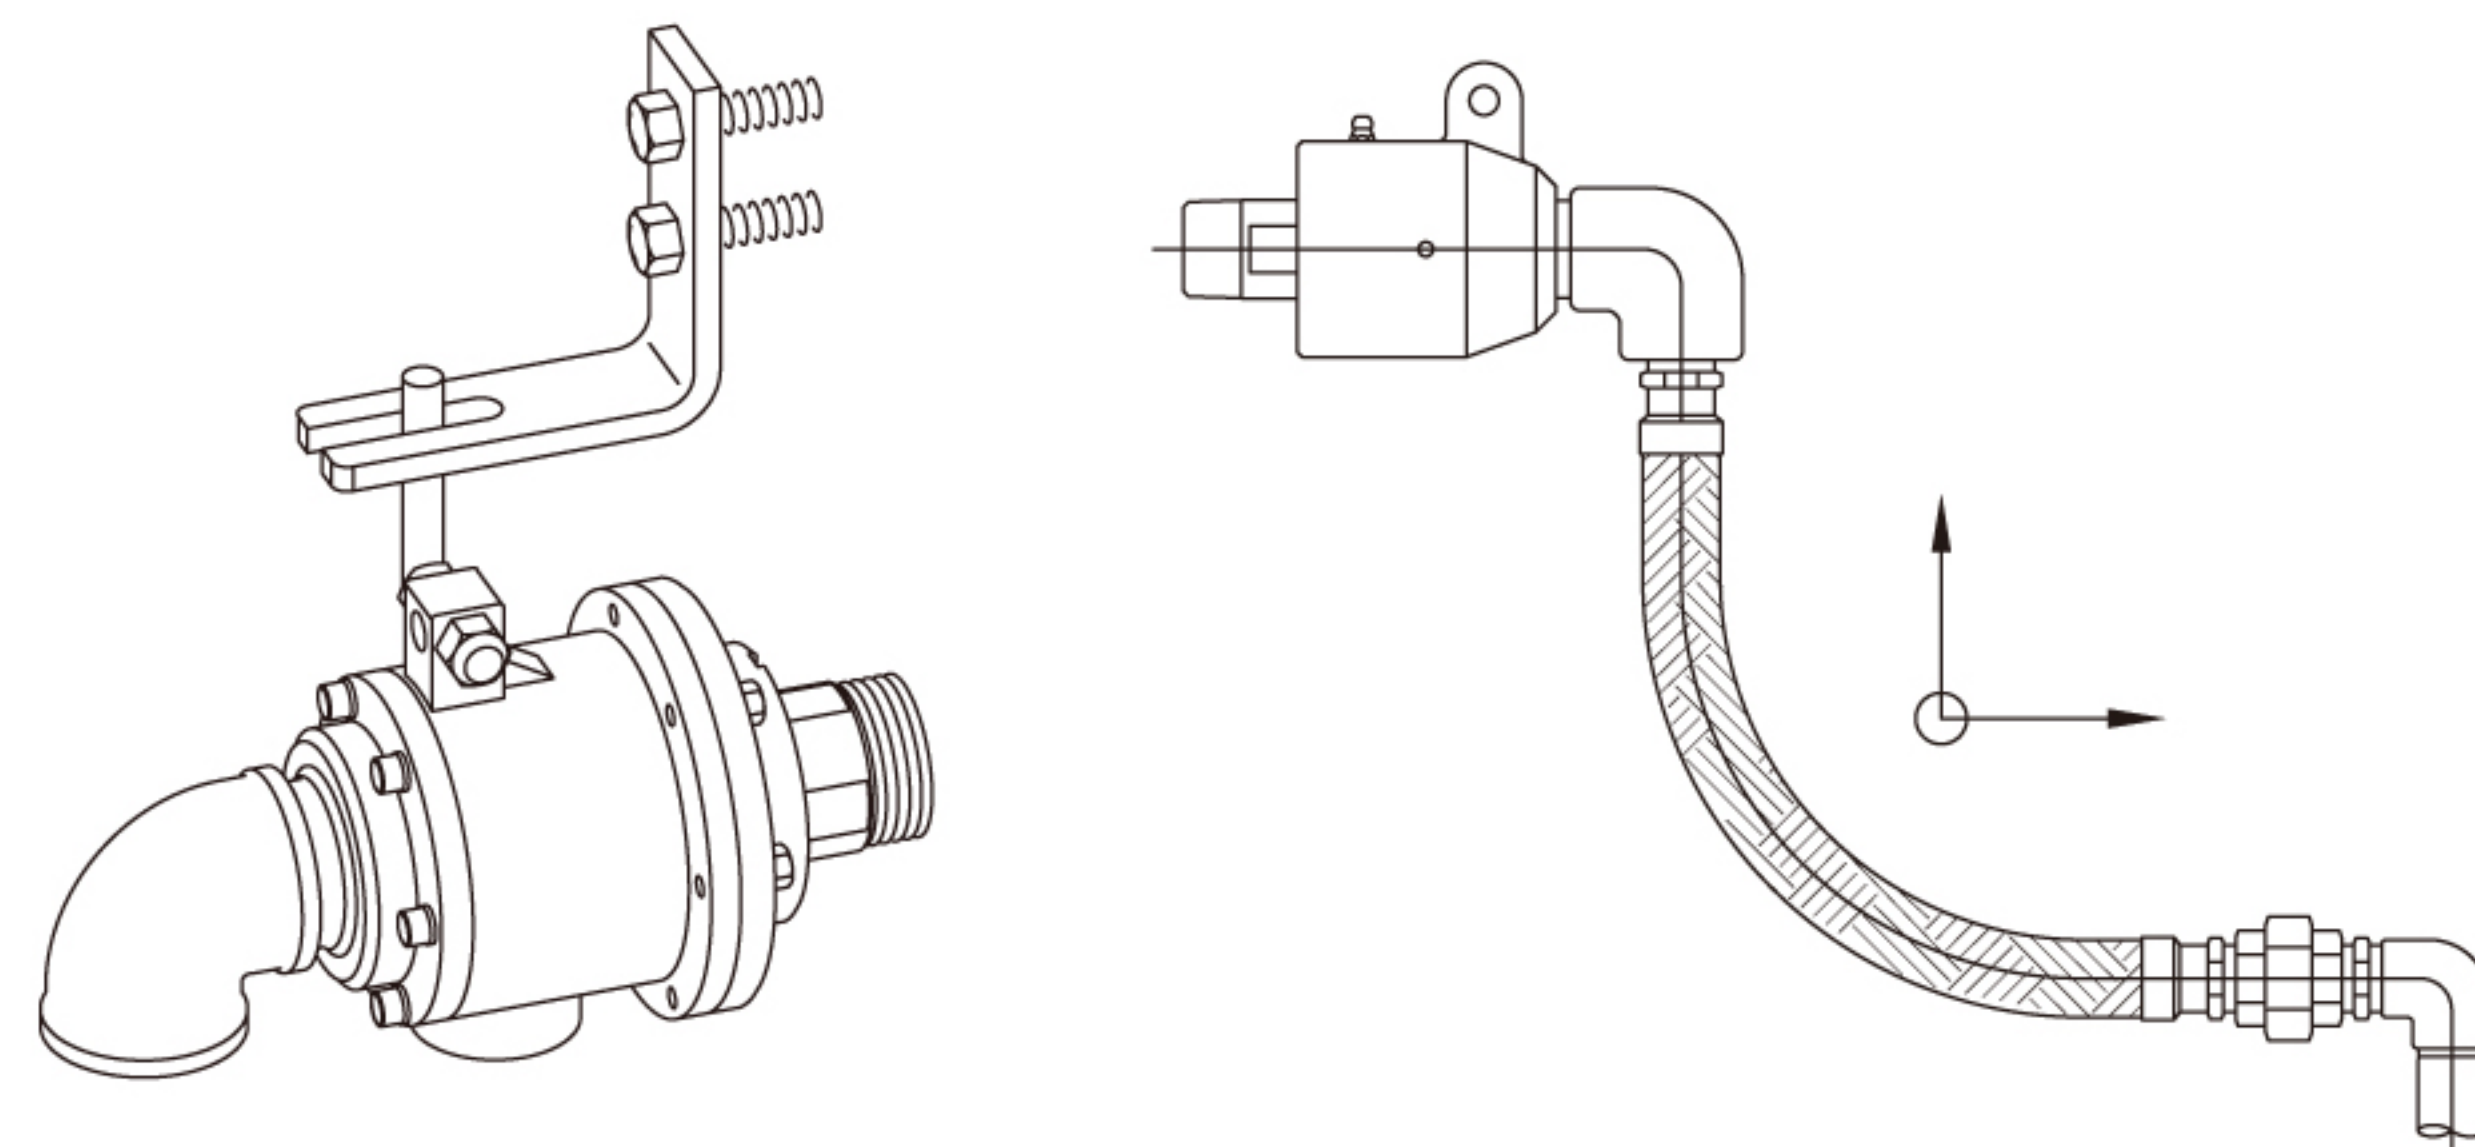
1. Carbon parts have been damaged and the level of leaking just depends on how serious the damage is. For most occasions, by well-fixing it we have to return the joints back to the original manufacturer.
2. What if the leaking problem hasn't been improved after installing the fixed / new joints?
 - a. There're still pellets and impurities in the tube or rollers, all process are required to be done again.
 - b. It's not acceptable being neglected about the other 2 factors, fixed structure and the installment of flexible hoses.

LIGHT DAMAGE

輕度磨損
